THERMOGRAPHY IN FOCUS

A Low *Delta-T* Can Be the Sign of a Much Bigger Issue

During a recent routine survey at a mine site on the west coast of Tasmania, a serious fault was identified inside the junction box of a 3.3kV electric motor.

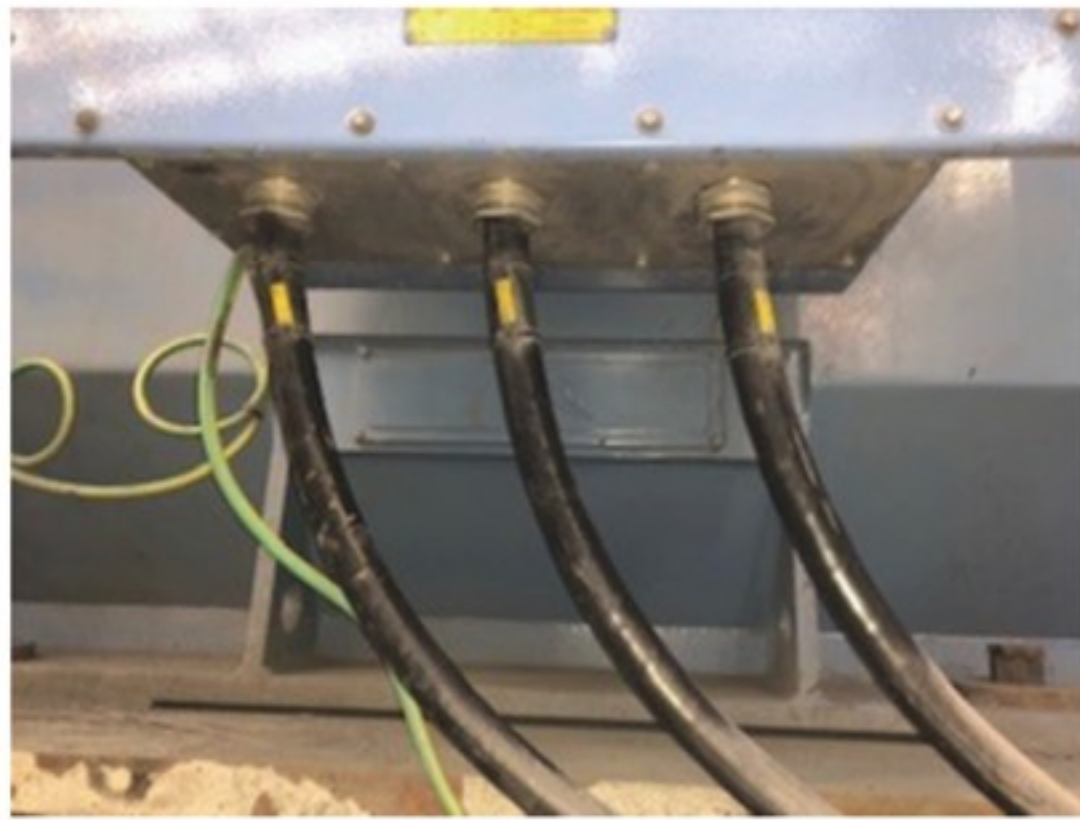
1. Lower front angle of incomer glands

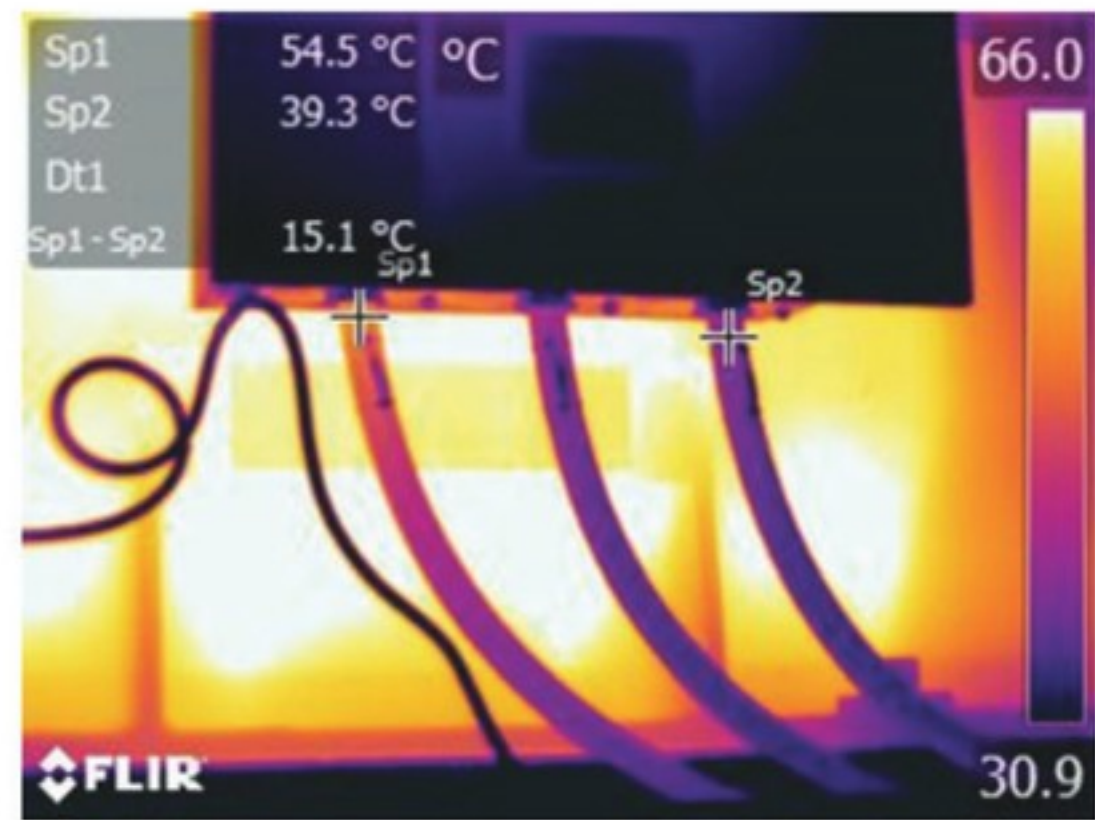
1. Conduction. The initial identification was made with a slight temperature elevation of the HV tail. While this elevation was small, it was the correct interpretation of the thermal heat pattern
2. Radiation. It was also the thermal pattern, showing an area on the cover of the junction box, caused by internal heat that provided a positive location of the fault behind the cover.

2. Elevated temperature noted at LHS phase

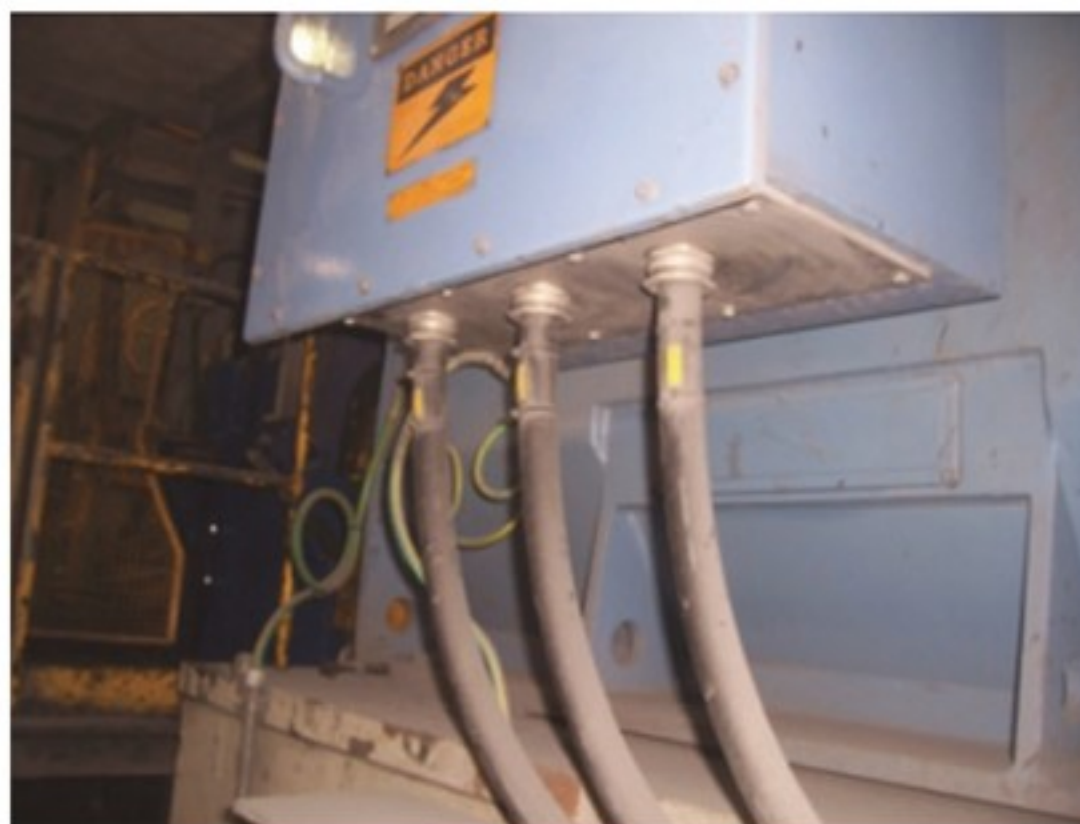
3. Lower right side angle of incomer glands

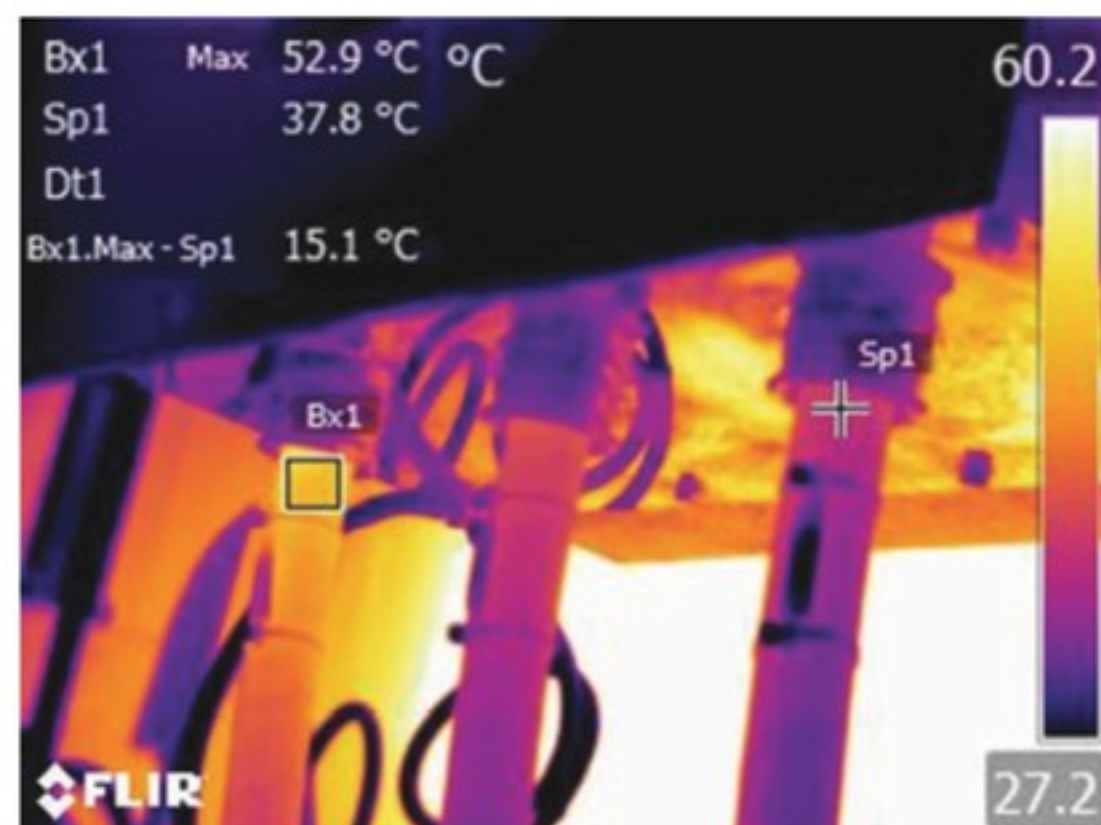
4. Again, elevation noted in LHS tail

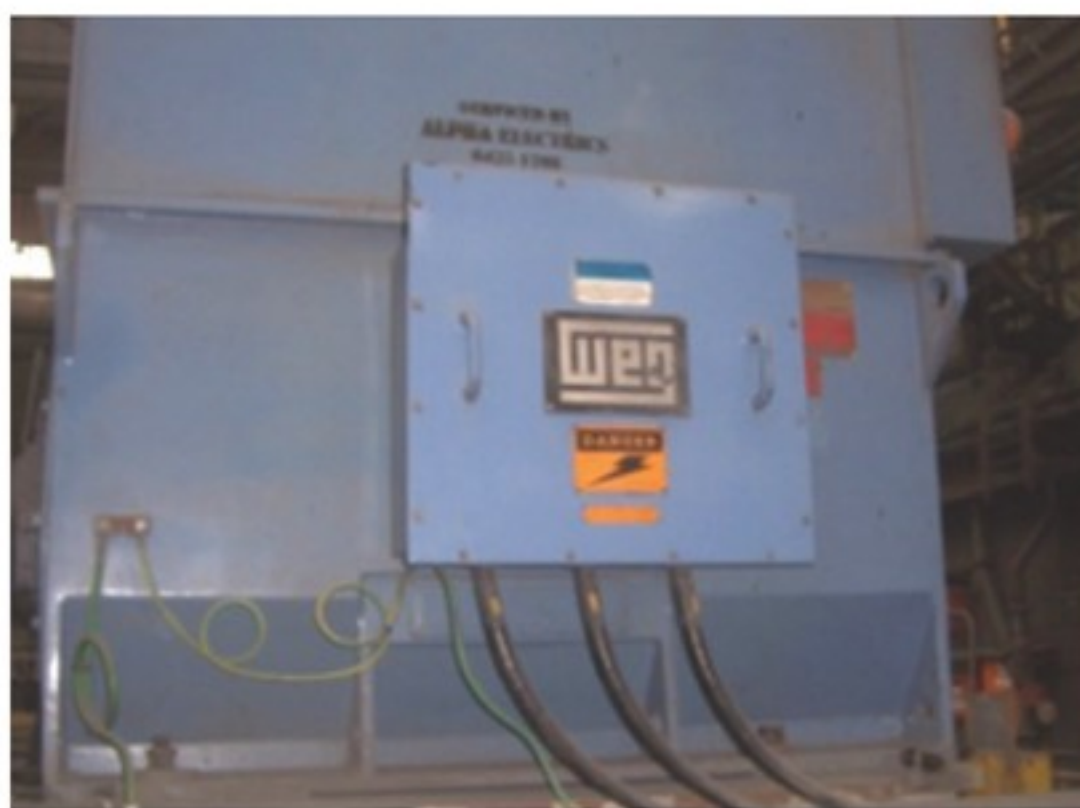
5. Junction box with cover in place

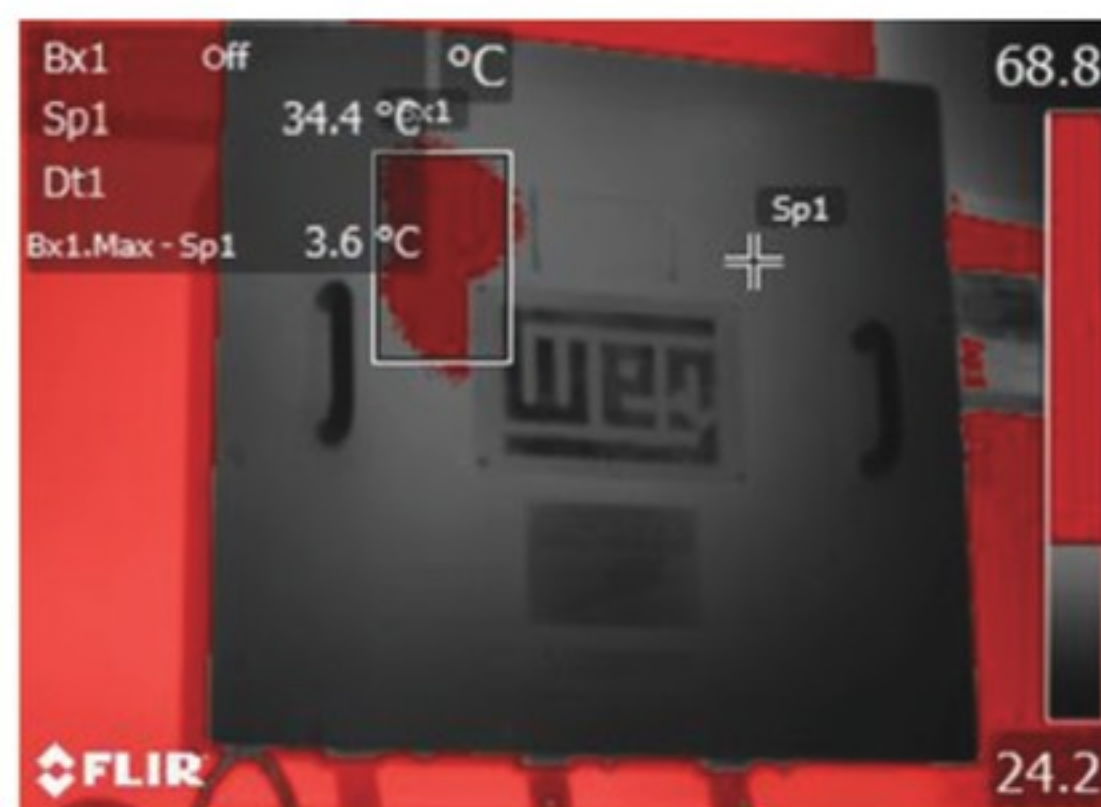
6. Warm area consistent with the tail elevation

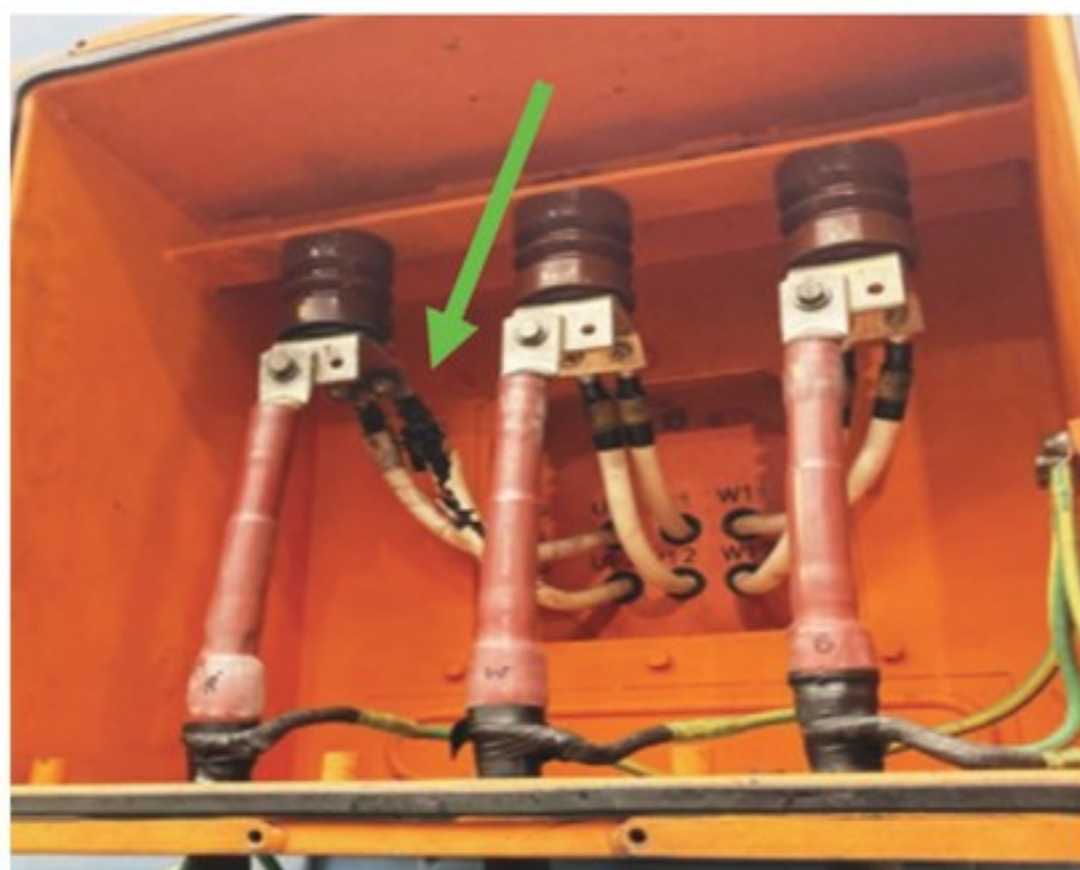
7. Cover removed showing three phases

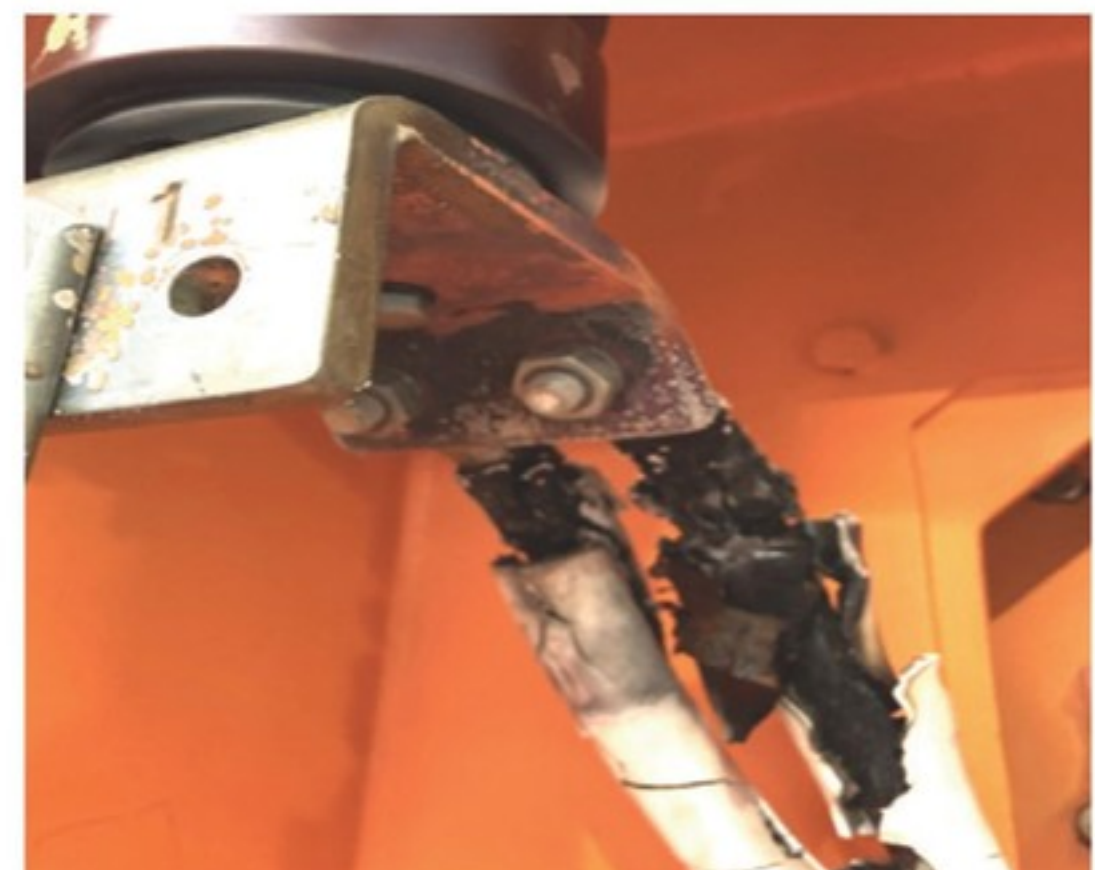
In this case, the low ΔT indicated a potential internal fault inside the equipment. While the variation was low, from the thermal images being displayed, it was evident that a critical fault was within the HV motor connections and would require immediate intervention.

8. Failing motor tail connection

The fault was repaired with the damaged tails replaced and all other connections checked, and the motor was returned to service. Follow up checks were carried out to verify that the work completed had been effective.
